COLD PATCH EVALUATION

CLIENT:	Michael Wertheim Road Stone Production, LLC 1230 River Road Charlottesville, VA 22901 C:434-906-1273 Michael@slwilliamson.com	PROJECT:	Cold Patch Evaluation
		Record No:	71R-3115
		Date:	April 7, 2014

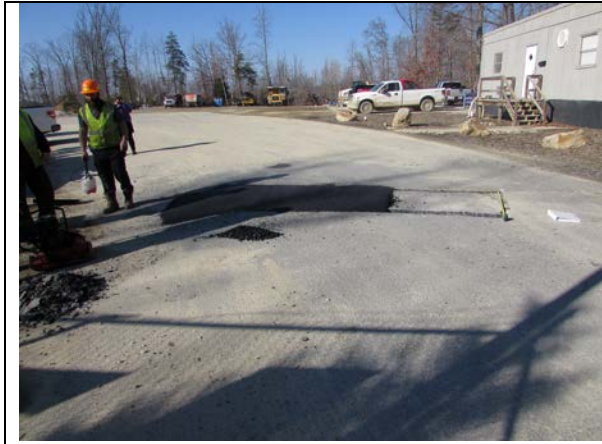
The edges of the dished area were chiseled to form more vertical edges, with loose material removed to a sound stable base. The area was wetted and broomed to remove standing water.

Figure 2. Hot Mix on left, chiseled area
 Cold patch evaluation

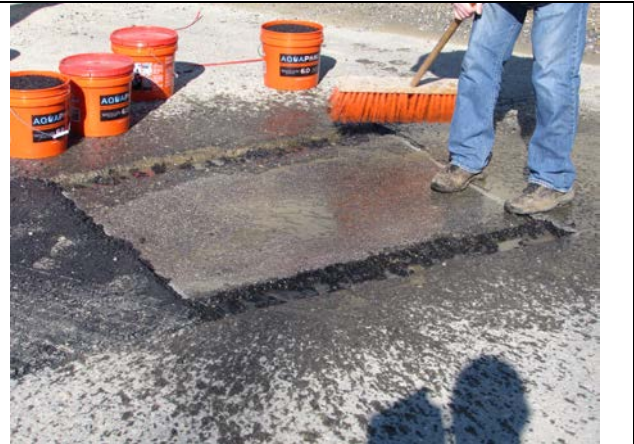
Figure 3. Area cleaned, wetted, & broomed
 near side Bond-X, far side Aquaphalt

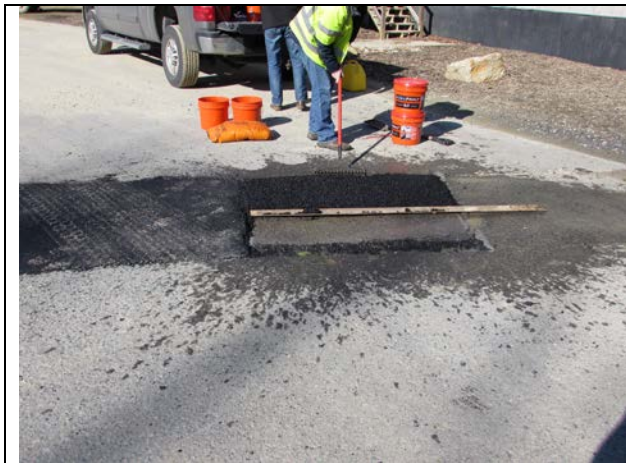
Aquaphalt was spread and raked to same level towards the inside portion of the quarry with Bond-X raked and spread on the entrance side of the quarry. The finer Aquaphalt was slightly easier to rake and spread than the coarser Bond-X material, but both materials are deemed similar in **workability**.

Figure 4. Aquaphalt spread & raked

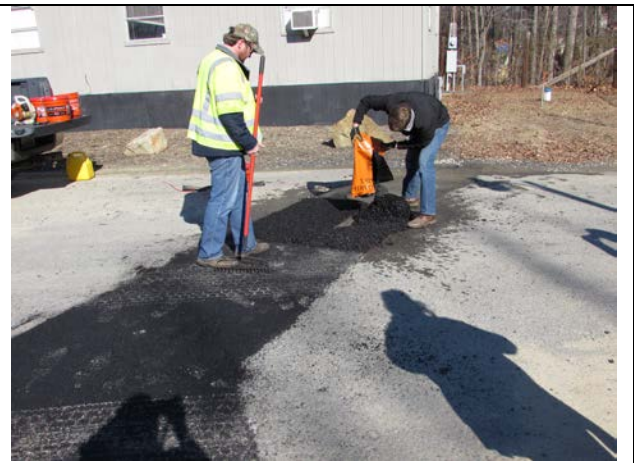
Figure 5. Bond-X spread & raked

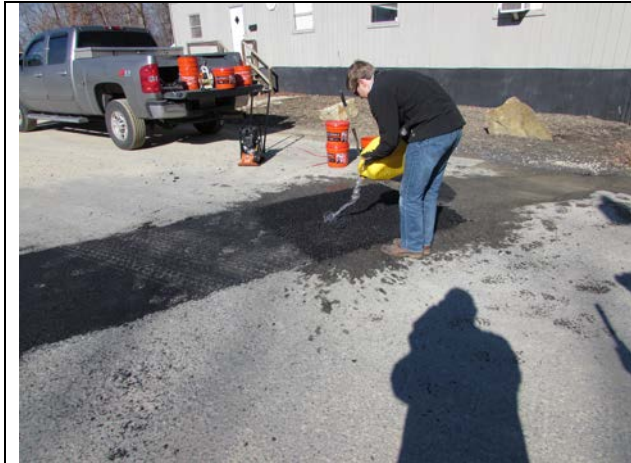
Figure 6. Both wetted 2 gallons water

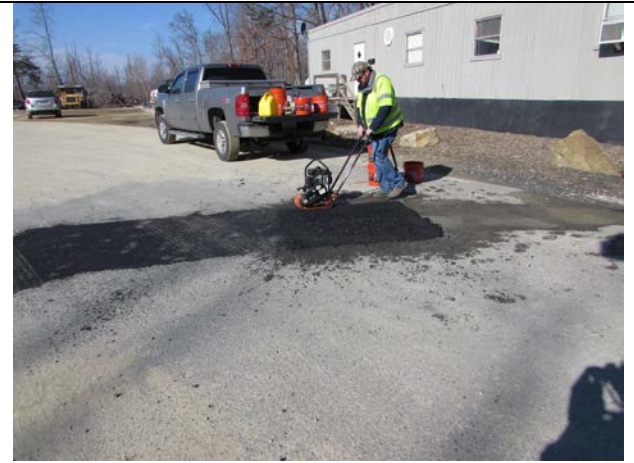
Figure 7. Both Compacted with Flat Plate

After both areas were shoveled, raked to crown and compacted with same number of passes using a Makita flat plate compactor. Temperature during placement varied from 38°F to 40°F. After compaction, the Bond-X had 99 pcf wet density with 37% voids, had a coarser surface texture and had more sheen. The Aquaphalt had 104 pcf wet density with 34% voids and had a finer surface texture with less sheen. At this time a loaded tandem axle truck left the quarry with a 5/16" rut measured in both the Aquaphalt (quarry side) and Bond-X (gate side) of the patch. Both materials have similar **stability**.

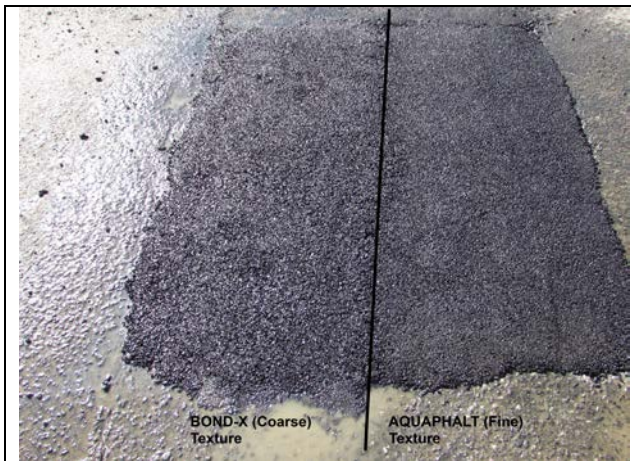
Figure 8. Surface Texture and Color

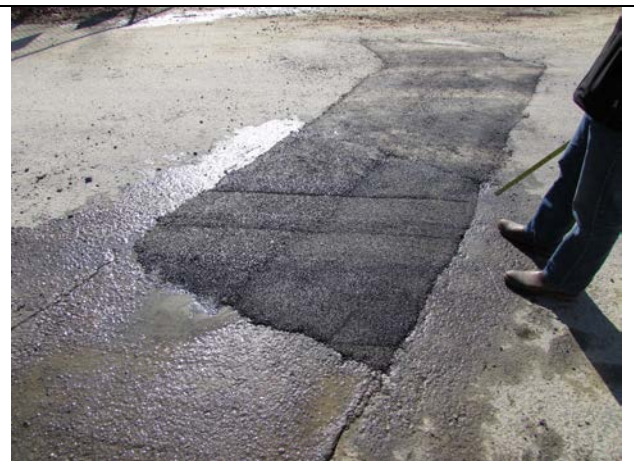
Figure 9. Loaded Tandem Axle Truck Rut

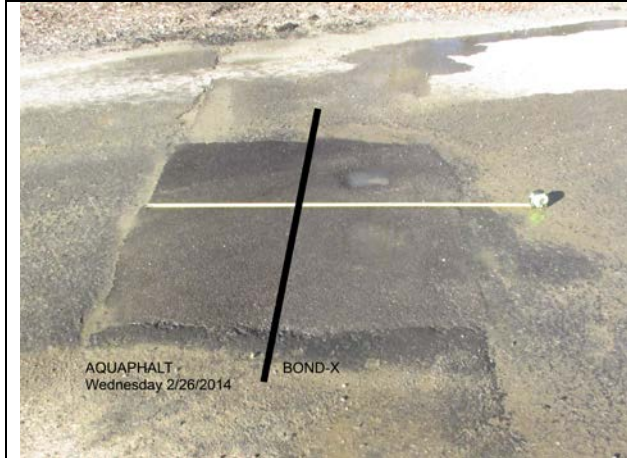
the cold patch. The Bond-X side had one depression where patch material had been removed approximately 1.25 inches to the original dished pavement and a second area where a depression had started (**durability** and **resistance to water action** issues)..

Figure 10. Patch loss of material

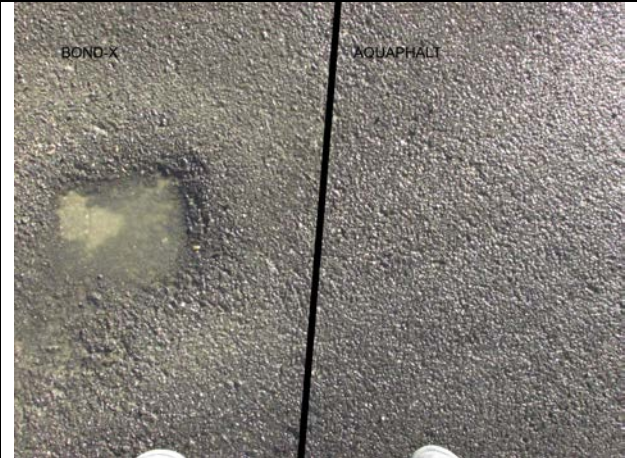
Figure 11. Close-up of Bond-X Patch

The Bond-X patch, probably due to overnight freeze and thaw cycles where water has frozen, is beginning to delaminate (see Figure 11) from the existing pavement.

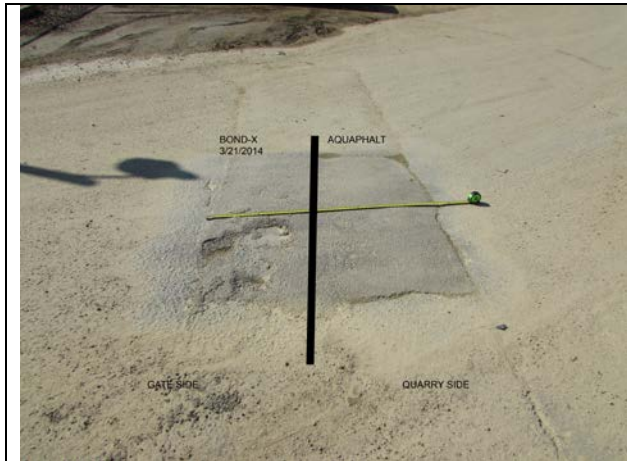
The second visit to evaluate the performance after installation was on Friday, 21 March 2014, 23 days after installation of the cold patches. Temperatures ranged from an overnight low of 1°F to a daily high of 75°F with 4 days of snow and four days of rain. The Bond-X side had one depression where patch material had enlarged from the first visit to a depth of about 1.25 inches to expose the original dished pavement. The delamination had started to connect to the earlier second depression observed starting on the first visit. Both cold patches had some raveling on the surface where wheel path wear had removed some of the surface aggregate from the binder.

Figure 12. Both patches 3/21/2014

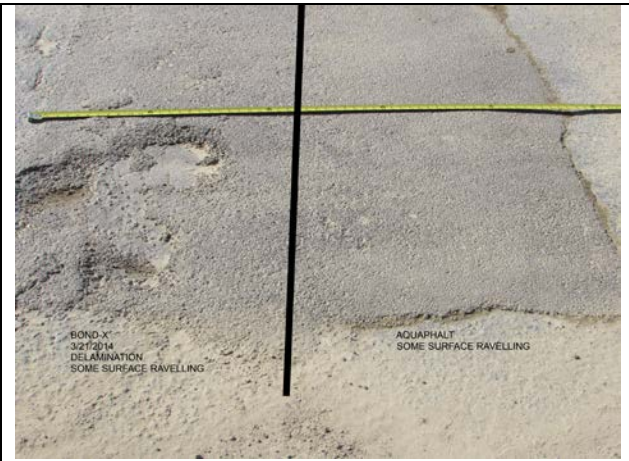
Figure 13. Bond-X delamination close up

Based on the above information where both materials were placed under the same wet conditions, had similar compactive effort, with equal ESAL loadings, equal snow/rain events, and equal freeze thaw cycles, the field conditions demonstrate that the Bond-X material delaminated due to **durability, stickiness** and **resistance to water action issues**, whereas the Aquaphalt material did not.
