COLD PATCH EVALUATION

CLIENT:	Michael Wertheim Road Stone Production, LLC 1230 River Road Charlottesville, VA 22901 C:434-906-1273 Michael@slwilliamson.com	PROJECT:	Cold Patch Evaluation
		Record No:	71R-3115
		Date:	April 7, 2014

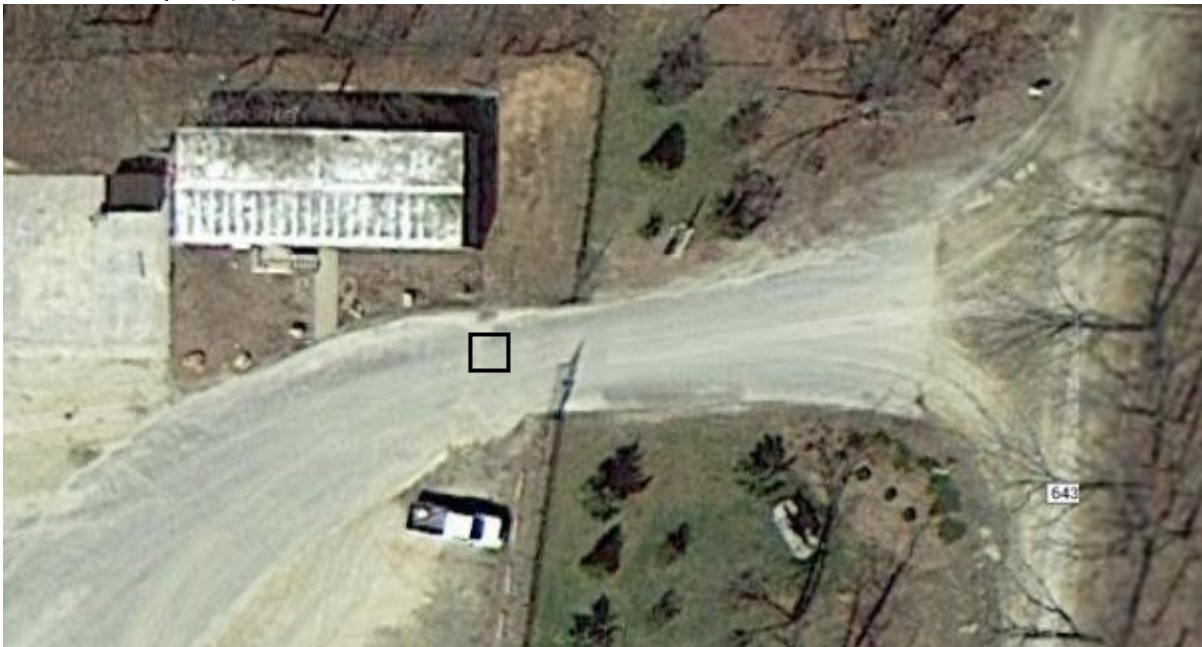
On Friday, 2/7/2014, a site needing repair was chosen that is located at the gated entrance to Rockydale Quarry. This location was selected for a field evaluation using both cold patch products to repair a dished area (1.5 to 1.75 inches in depth) at the entrance (Refer to sketch). Note that location is such that the wheel track on the passenger side of unloaded tandem axle trucks entering the facility would traverse both products (the Seaboard Patch first followed by the Aquaphalt patch) and loaded tandem axle trucks leaving the quarry loaded with crushed rock would have the driver side wheels traverse both products (first the Aquaphalt, then the Seaboard Asphalt).

Figure 1. Site Map with rectangle showing dished area.
